Garland Inspection Services, Inc.

1234 School House Road
Yourtown, US 12345

Prepared for: Bob Smith

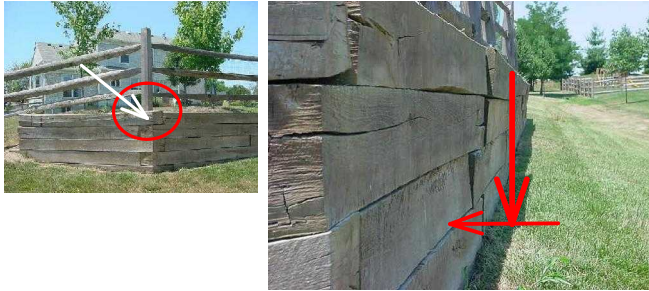
Retaining Walls: Railroad ties - The wall is showing signs of movement, but appears to be stable at this time. A qualified contractor is recommended to evaluate and estimate repairs to maintain the wall.

1. **Vegetation:** Shrubs with some weeds
2. **Retaining Walls:** Railroad ties - The wall is showing signs of movement, but appears to be stable at this time. A qualified contractor is recommended to evaluate and estimate repairs to maintain the wall.

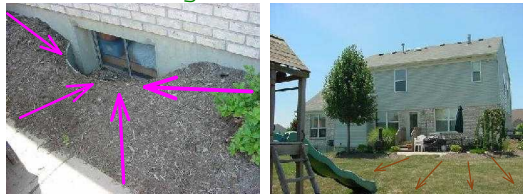
Grading: Moderate slope - The grade and landscaping materials are too high and extend above the window well at the Northeast rear of the home. Recommend that the grade be reduced or the metal window well soil retainer be replaced with a taller unit to keep the mulch and soil beds from washing into the well.

1. **Deck:** Treated wood - The deck has been built below acceptable building standards and is not safe in its current state. Recommend further evaluation and estimate to bring deck up to an acceptable building standard.
2. **Grading:** Moderate slope - The grade and landscaping materials are too high and extend above the window well at the Northeast rear of the home. Recommend that the grade be reduced or the metal window well soil retainer be replaced with a taller unit to keep the mulch and soil beds from washing into the well.

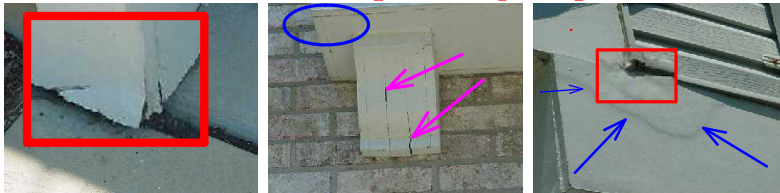
Trim: Composite material - Note: Damaged wood areas should be checked while doing the repair and replaced if wood rot is present.

1. Water damage to trim wood at either side of garage door from moisture wicking into the finished particle board. The surface is starting to delaminate. Recommend repair/replacement of the trim boards and silicone seal wood that is in contact with concrete to prevent wicking.

2. The wood window boxes have water damage and will require repair/replacement. The wood has started to separate at the supports and at the corners of the window boxes.

3. The trim board at the southwest corner of the porch has water damage due to water penetration and will require repair/replacement of the wood. The trim board extends out creating a ledge allowing water to collect on the top edge of the board and cause the wood to rot.

Recommend estimate/repairs by a qualified contractor.

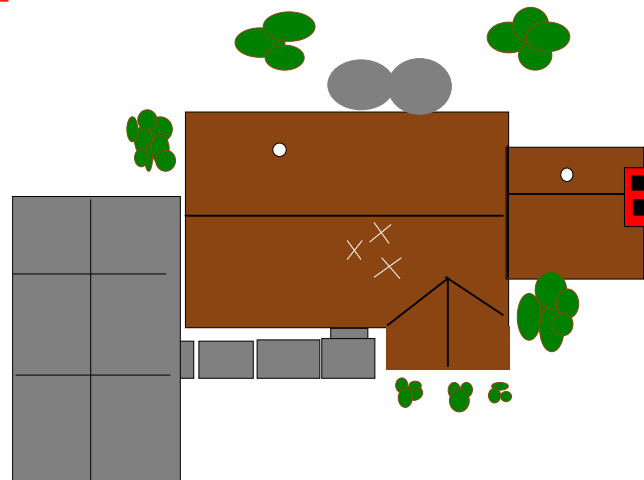
Defective **Material:** Fiberglass shingle - Missing roof shingles from wind damage as marked "x" in diagram. Repairs are required.

5. **Main Roof Surface Material:** Fiberglass shingle - Missing roof shingles from wind damage as marked "x" in diagram. Repairs are required.
6. **Leader/Extension:** Underground conductors - Reconnect to downspout where pulling loose.
