Garland Inspection Services, Inc.

1234 School House Road
Yourtown, US 12345

Prepared for: Bob Smith

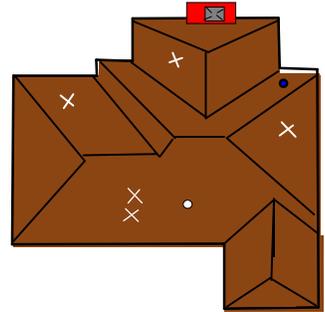
Roof Diagram

Material: Fiberglass shingle - Nail popping through shingle surface in various locations causing potential water intrusion (see diagram above marked "x")

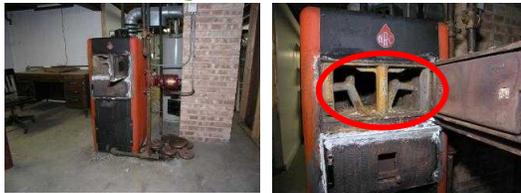
Marginal Heating System Operation: Recommend replacement - **Boiler system is antiquated and lacks safety features found on newer units including non-sealing combustion chamber which can cause health issues**

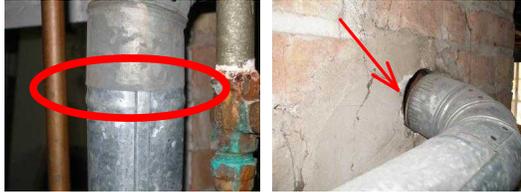
Defective Flue Pipe: Single wall - **Install screws at exhaust vent piping fittings, loose piping at chimney**

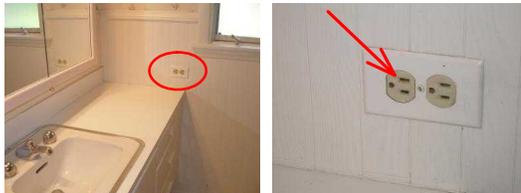
Defective Electrical: 110 VAC - **Non-GFCI circuit, Reversed polarity present**
